INSPECTION REPORT

For the Property at:
123 ANYWHERE
ANYPLACE, ON

Prepared for: JOHN SMITH
Inspection Date: Tuesday, January 6, 2009
Prepared by: Richard Hutchinson

RE: Report No. 1054
123 Anywhere
Anyplace, ON

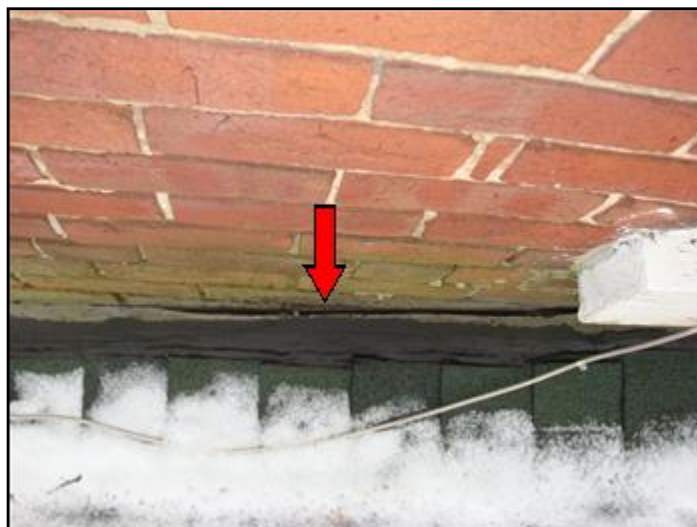
1.

Sloped roof flashings \ Roof/wall flashings

Condition: • [Damage, loose, open seams, patched](#)

Implication(s): Chance of water damage to contents, finishes and/or structure

Location: Southeast Exterior Wall Addition

Task: Repair or replace

Time: Immediate

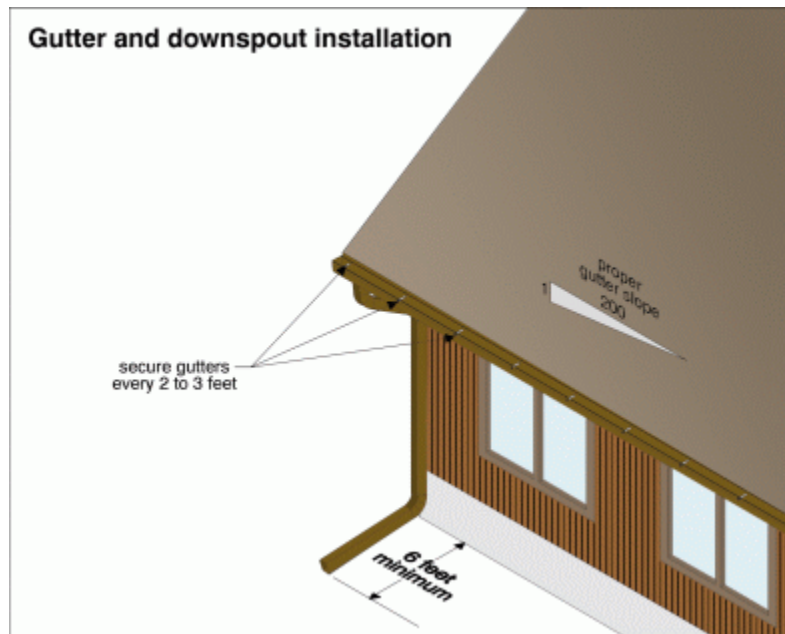
Roof drainage \ Gutters

Condition: • [Missing](#)

Implication(s): Chance of water damage to contents, finishes and/or structure

Location: Various

Task: Provide

Time: Immediate

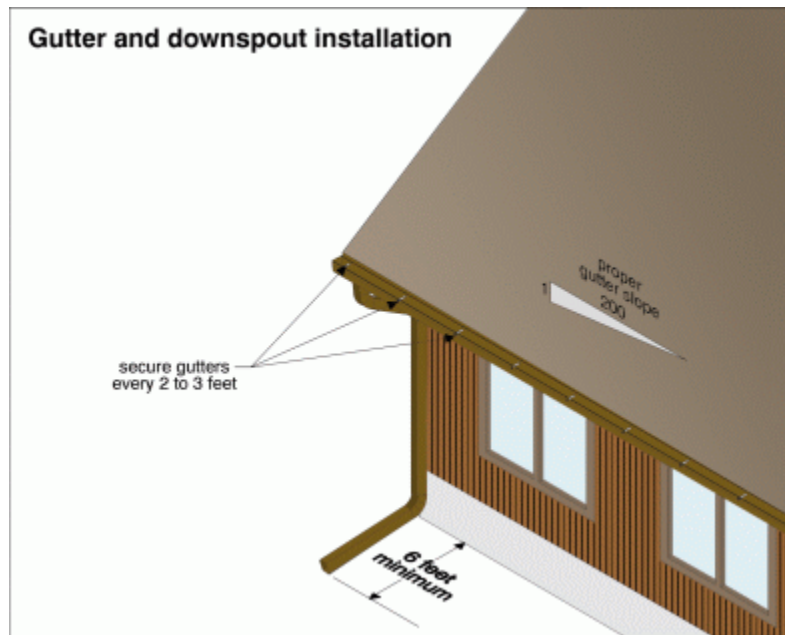
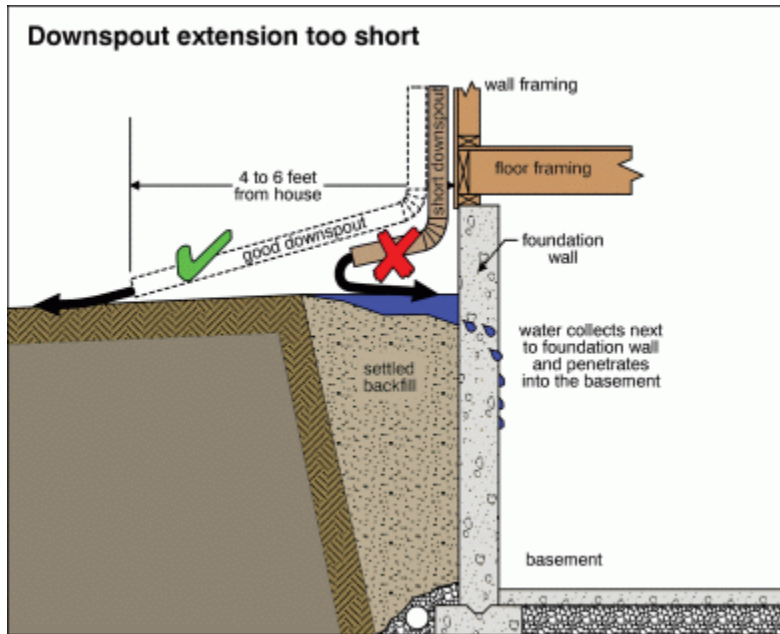
Roof drainage \ Downspouts

Condition: • [Downspouts end too close to building](#)

Implication(s): Chance of water damage to contents, finishes and/or structure

Location: South Exterior

Task: Correct

Time: Immediate

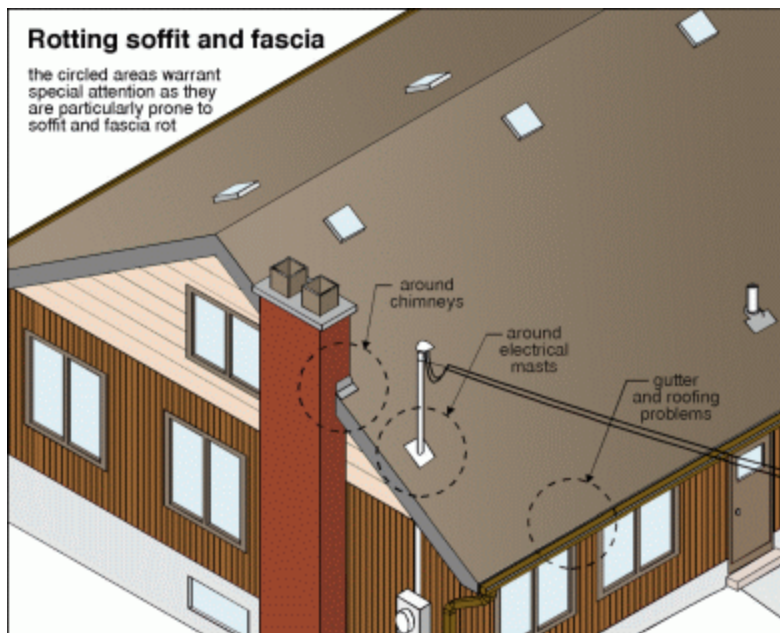
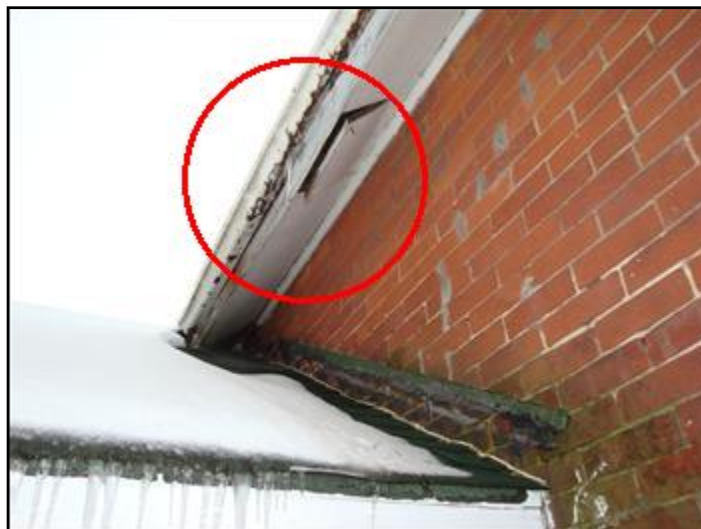
2.

Walls \ Soffits and fascia

Condition: • [Loose or missing pieces](#)

Implication(s): Cosmetic defects | Chance of water damage to contents, finishes and/or structure | Chance of pests entering house

Location: East Second Floor

Task: Repair or replace

Time: Less than 1 year

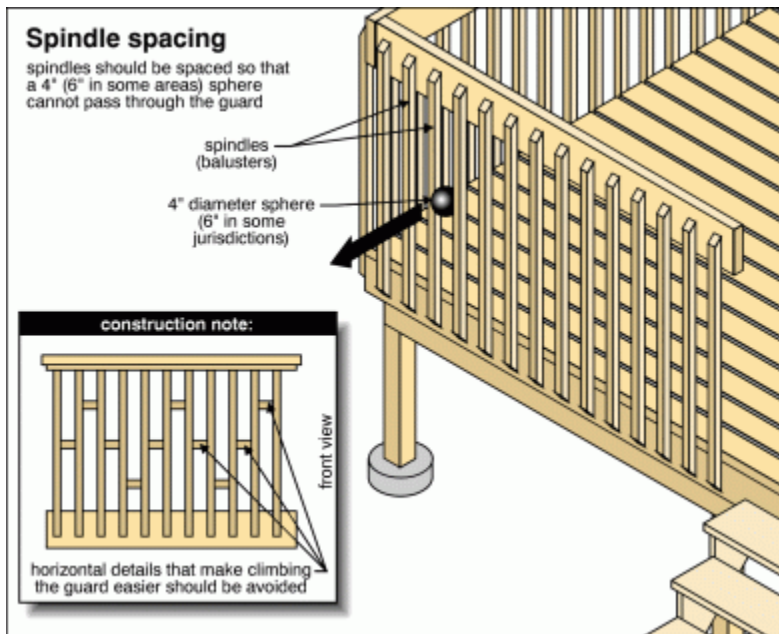
Porches, decks, steps, patios and balconies \ Handrails and guards

Condition: • [Spindles missing](#)

Implication(s): Fall hazard
